## Ricoh IM C2000 drum unit rebuild instructions.

### Tools and materials needed to rebuild the drum unit:

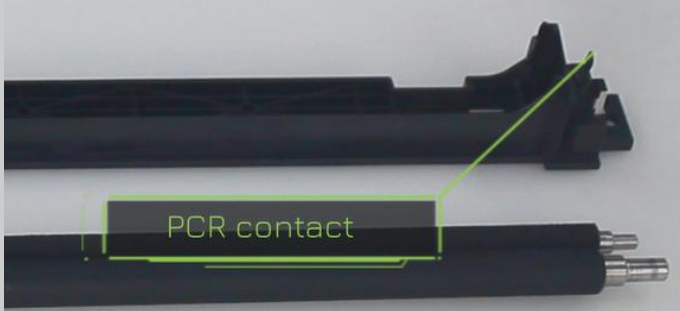
21.	<p>Clean the PCR contact with a cotton swab, then apply a small amount of conductive grease on it</p>
